**Characteristics of Soils of Iwogban Gully in Edo State and their Implications for  
Household Food Security**

**SUB THEME: WATER INFRASTRUCTURE AND REVITALIZATION OF  
AGRICULTURAL PRODUCTIVITY**

***Book of Proceedings, 14th Nigeria Association of Hydrological Sciences Conference  
(Okitipupa 2024) held at Olusegun Agagu University of Science and Technology,  
Okitipupa, Ondo State, Nigeria, November 5 - 8, 2024***

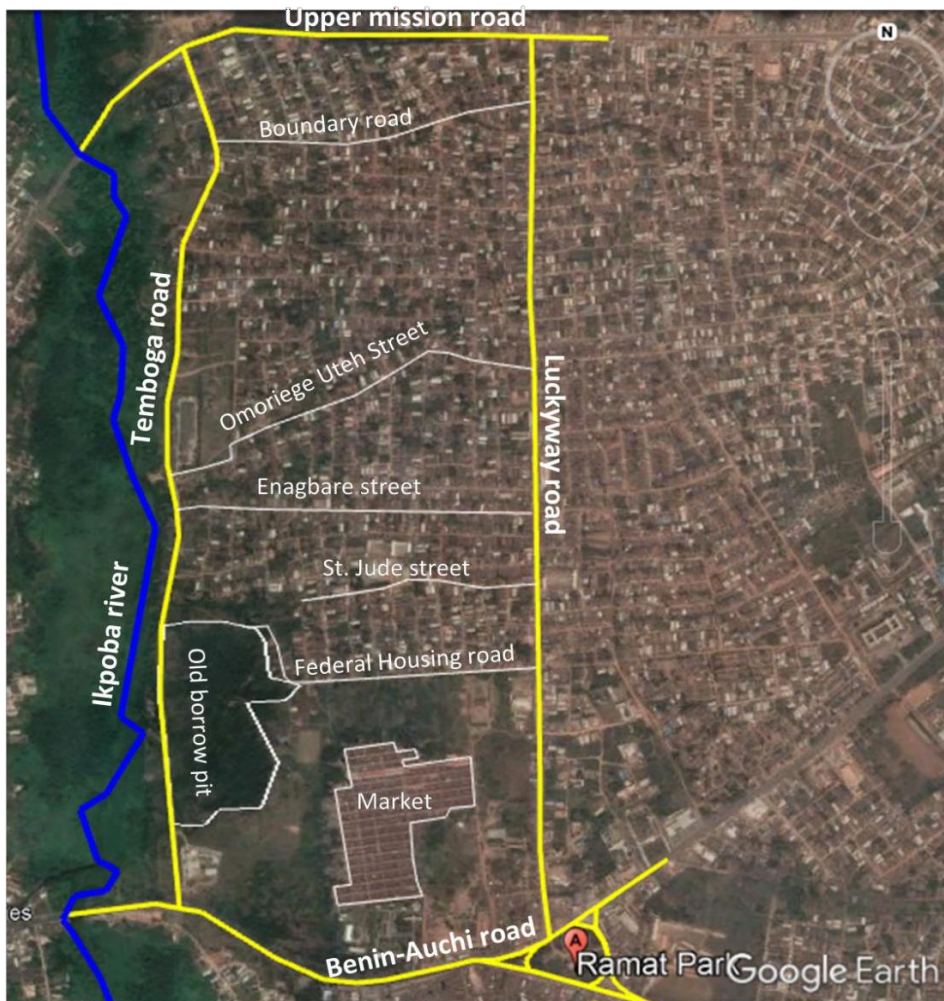
Fig. 2(b) Google Earth Imagery of Catchment Area  
Source: Edo-FEWMA, 2023

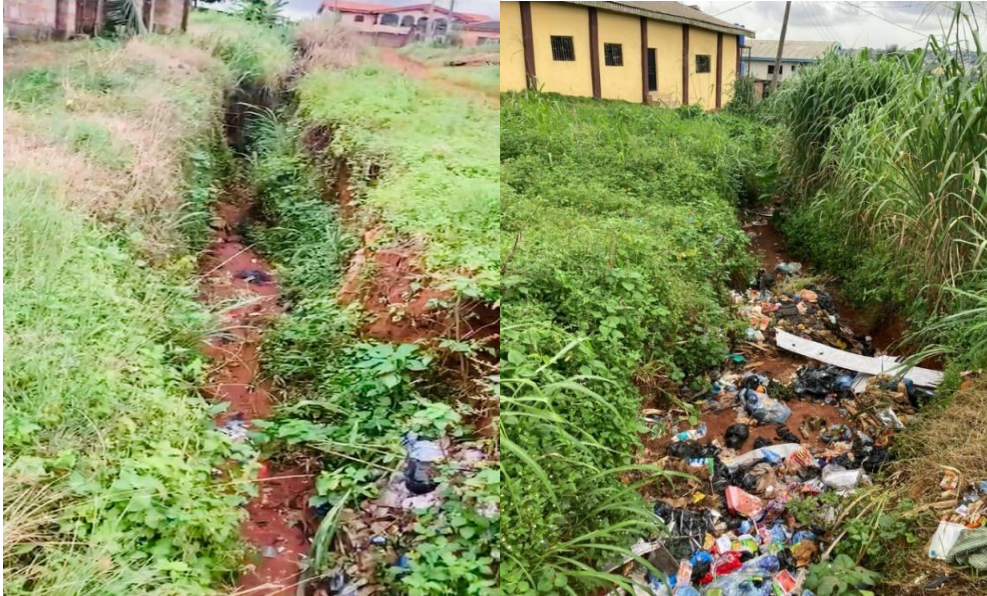
Fig. 2(c)View of gully erosion in the study catchment Fig. 2(d)Gully scar used as waste dumpsite

seen in Fig2(a), Topography and terrain, deforestation, construction and poor farming systems and land use change have also contributed to soil erosion within the catchment resulting in gully formation, The impacts of anthropogenic activities include:

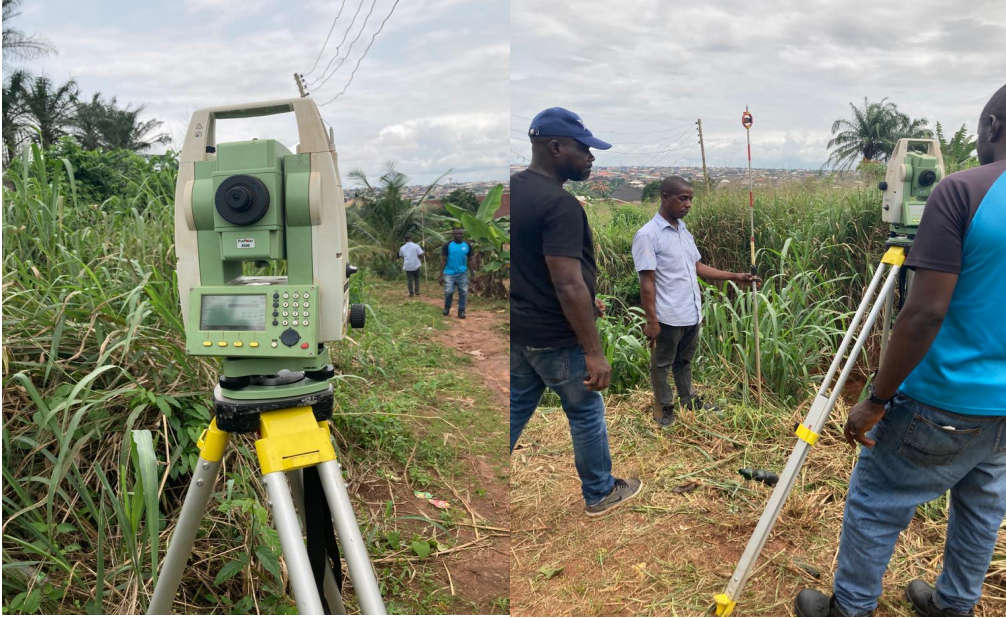
Fig.3(a)Total station set up

Fig.3(b)Site Survey

Ground survey was carried out to determine the following. Gully elevation, profile, longitudinal and transverse sections at a regular interval not more than 25m. A total of 16 bench marks (BM1-BM16) were established from the gully head to gully mouth. This was done using a Total Station which involves the following stages. i. Establishment and marking of point of reference. ii. Setting the tripod at the reference point, iii. Attaching the tribrach to the tripod and adjusting as necessary, iv. Setting the total station on the tripod with connected cables. v. Necessary setup information was imputed into the total station, such as the known coordinates of the setup point

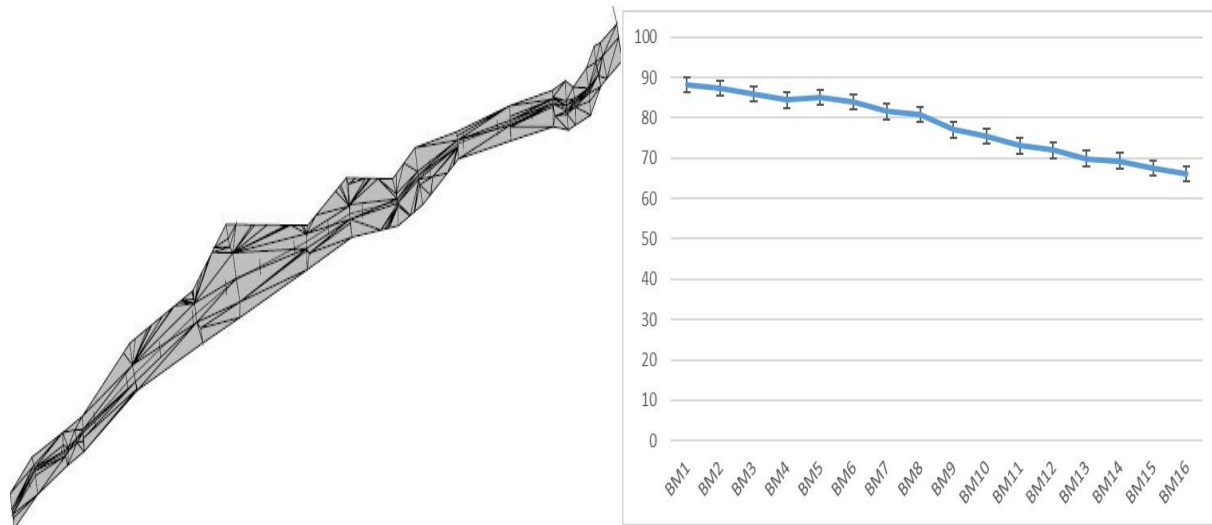
Fig 4.1(a) and (b) Gully Longitudinal profile and site plot of Iwogban

and the instrument height before the ground survey data were acquired. The gully longitudinal profile and site plot is shown in Fig. Fig 4.1 (a) and (b)

The gully horizontal profile and site plot in Fig 4.1 (a) and (b) from the topographic survey result reveals a slopy terrain from the gully head at BM1 to the gully mouth at BM16 implying that the topography of the study area is a gentle slope. Since slope has a great influence on erosion, the

presence of heavy run-off and high rainfall intensity can result in increased soil erodibility and gully expansion in the study area.

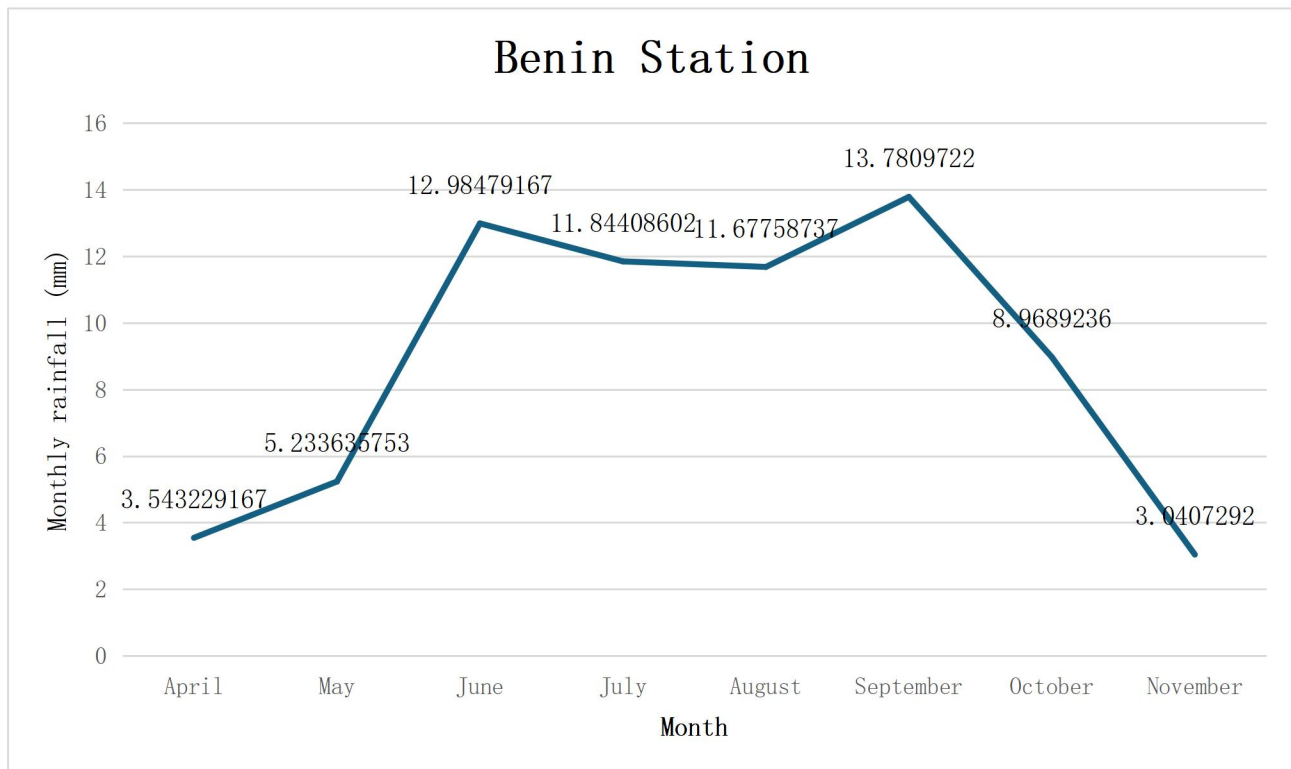
Fig. 4.4 Rainfall graph for Benin city April-November, 2023

Studies of rainfall characteristics which includes the rainfall amount, intensity and its distribution pattern from April to November 2023 for Benin City as well as the watershed characteristics such as shape and size and how it affects the runoff rate were done. Erosivity which consists of amount of rainfall and precipitation intensity is the most important climatic factors affecting the amount and rate of soil erosion. The intensity and amount of rainfall in recent times has resulted in some of the most significant erosion experienced within Benin City in the last years. With climate change, heavy and damaging storms will continue to increase in frequency and gully processes will keep occurring. The hydrological data obtained from Nigerian Meteorological Agency was used for this analysis. The result shows the rainfall intensity at the peak of raining season June and September where visible maxima is evident. During this period, the rate of soil erosion and erodibility is high which also contributes to land degradation resulting in loss of fertile land for household food production.

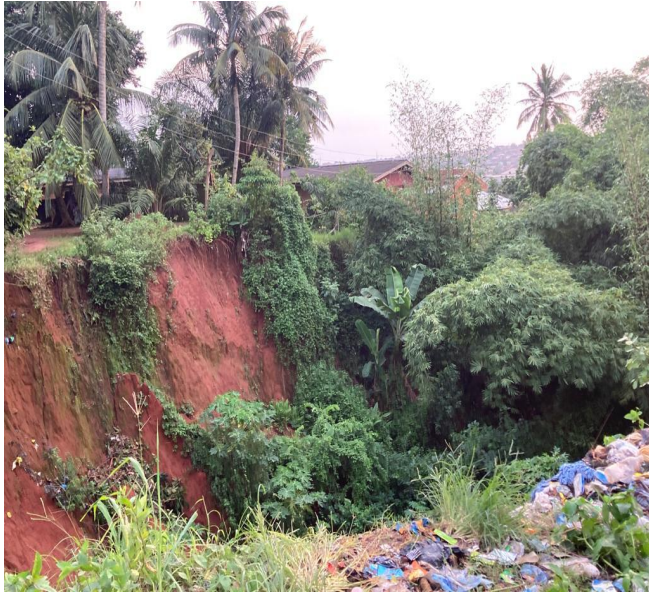
Fig 4.5 (a) Abandoned farmland in the study area

The effects of soil erosion and the propagation of gully in Iwogban catchment has resulted in loss of arable land. The topsoil, which lies closest to the surface of the land that contains essential nutrients for crop growth is endangered by erosion. This has resulted in loss fertile soil, reducing agricultural productivity and food security in affected communities. Some occupants have abandoned their buildings and household gardening for safer locations due to threat posed by the presence of the gully and can no longer practice their subsistence farming for food production as well as generating income for them. As seen in Fig 4.5 (b) sidewalls and demarcations was done

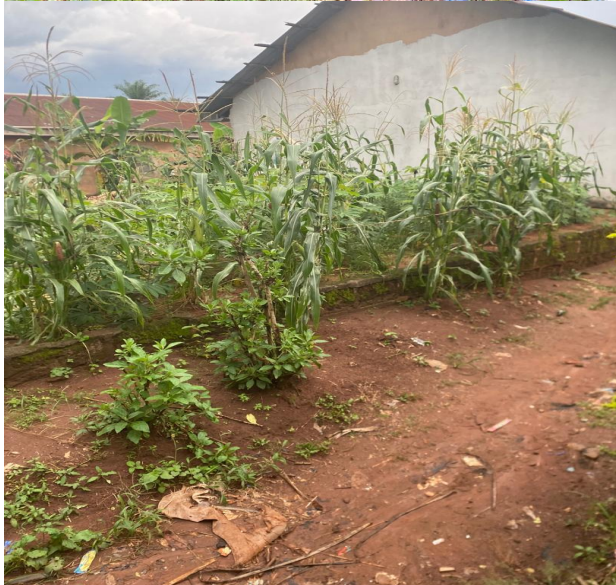
(b) Coping mechanism for household gardening

along the erosion route as means of controlling erosion to protect household gardening for food production.
